Repair Measures for Existing Bridges

Restoration of Deteriorated Concrete Gelber Bridge

Introduction to Fatigue Crack Cases: Fatigue Crack in Vertical Braces

Identifying Fatigue Crack Causes and Verifying Reinforcement Effectiveness Through Stress Measurement Based on Load Tests (Case Study)

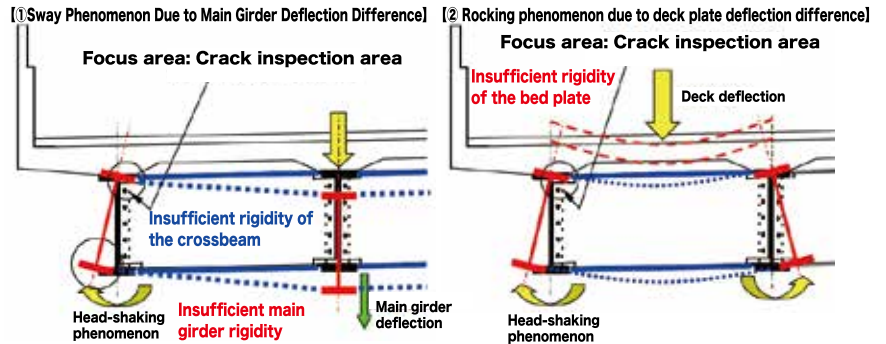
The primary causes of cracks at the upper flange and vertical stiffener joint, as shown in the right figure, are believed to be either ① the sway phenomenon due to main girder deflection differences or ② the sway phenomenon due to deck slab deflection differences. The main cause of ① is considered to be insufficient stiffness in the cross girders connecting the main girders and in the main girders themselves. The main cause of ② is considered to be insufficient stiffness in the deck slab itself. The countermeasures required differ significantly depending on which type is responsible. At Josei, we conduct stress measurements based on load tests to elucidate fatigue crack mechanisms and propose optimal countermeasures

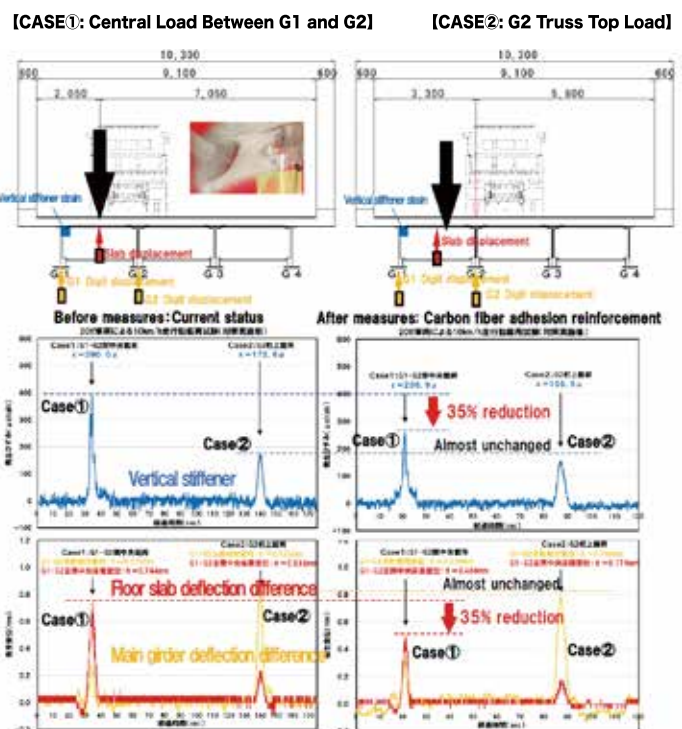
The figure above illustrates a case where the cause of cracks occurring at the connection between the upper flange and vertical stiffeners in a four-main-girder simply composite girder bridge was elucidated through stress measurements based on loading tests.

CASE① shows measurement results when the load was applied centrally between G1 and G2. CASE② shows results when the load was applied on girder G2. Judging from these results, the vertical stiffener's induced strain was measured to be larger in CASE②'s loading pattern than in CASE①. This indicates that cracks occurred due to rocking caused by deck deflection differences, resulting from the deck's low stiffness.

As shown in the lower left photo, numerous bidirectional cracks had already developed in the deck slab. Although deck replacement was proposed, the route carries heavy traffic, and implementing all traffic restrictions, including alternating one-way traffic, was difficult at this stage. Therefore, an emergency countermeasure using carbon fiber bonding was implemented. The lower right diagram shows the stress measurement results before and after this emergency countermeasure, confirming that it achieved a sufficient stress reduction effect

⇒When the slab deflection difference is large, the vertical stiffener strain is large!
⇒ Case①: 35% reduction
⇒ Case②: Virtually unchanged
