Repair Measures for Existing Bridges

Investigation of Causes and Countermeasure Design for Fatigue Cracks in Steel Bridges and Post-Countermeasure Effect Verification (Part 2)

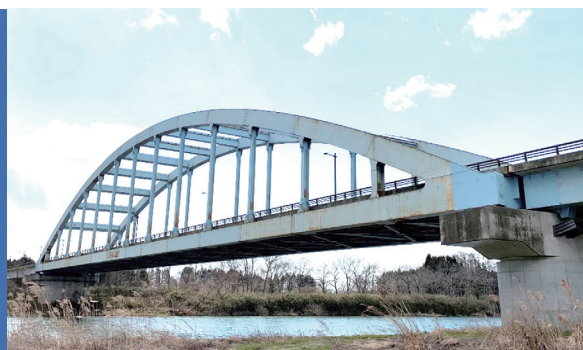
This case involves cracks that developed in the vertical members of Rose Bridge, as shown in the photograph. As indicated by the ● mark in the right diagram, the crack locations were concentrated at the base of the vertical members and were only confirmed on the Tokyo side. The completion records revealed that different manufacturers and construction companies were responsible for the Tokyo and Aomori sides. Below, we present Josei's investigation into the cause of the cracks and the proposed countermeasures.

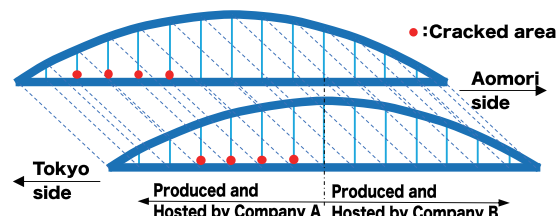
The vertical member where cracks were confirmed has a structure where Member 1 and Member 2 are joined with a fillet plate ($t=20\text{mm}$), as shown in the right diagram. The cracks were confirmed in the section with a change in cross-section on the Tokyo side (manufactured and erected by Company A). Visual inspection at the site revealed curved deformation at the boundary between Member 1 and Member 2 (no deformation was observed on the Company B side). This curved deformation was determined to have occurred during fabrication due to web width error, causing forced deformation when Members 1 and 2 were tightened with high-strength bolts.
