## Temperature Stress Management During Concrete Placement

# Construction Management for Seismic Reinforcement Work on Concrete Bridge Piers Damaged by the Kumamoto Earthquake

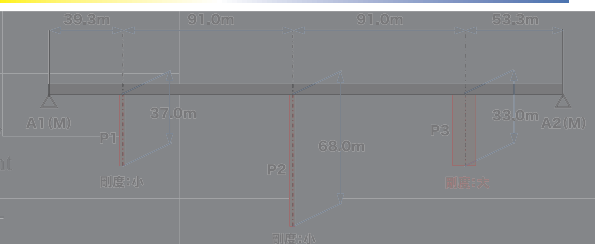
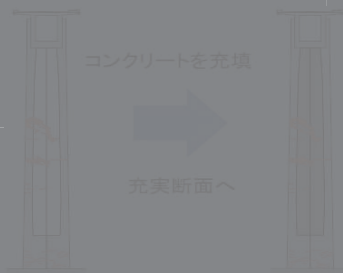
Due to the high stiffness of Pier P3, damage was concentrated in the form of through-cracking and fractures at the welded joints of the main reinforcement (see photo below right). As this pier has a hollow section, concrete was filled into the pier's hollow interior to reliably restore its stiffness, thereby recovering the sectional rigidity that had been reduced by the damage.

【P3橋脚貫通ひび割れ】

【主鉄筋継手部圧接箇所の破断】

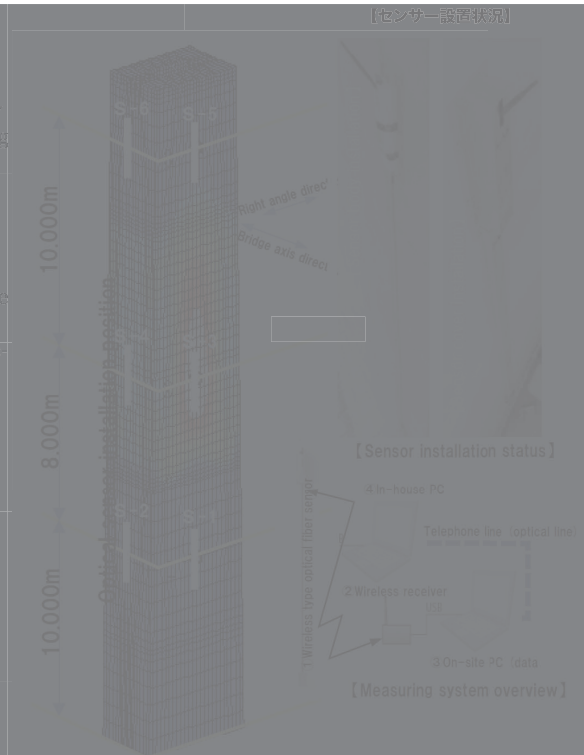
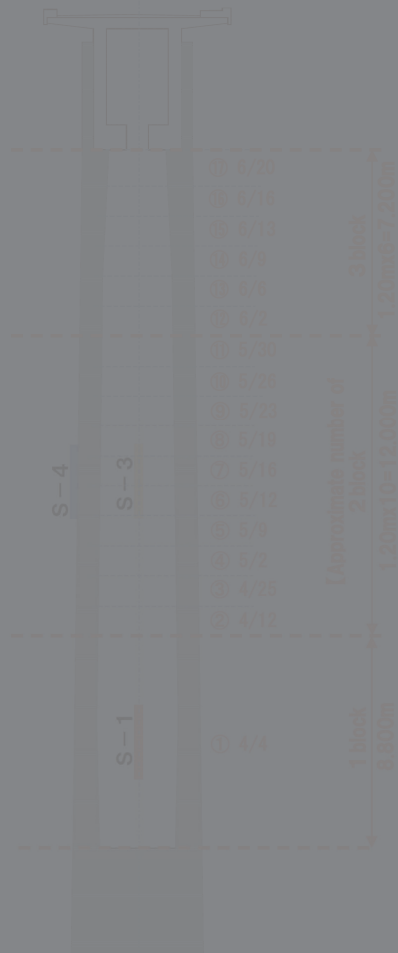
The figure below shows the strain monitoring trend for representative measurement positions.

The selected measurement locations are the 'S-1 Sensor' with a high per-pour volume, the 'S-3 Sensor' located at the center of the pier, and the 'S-4 Sensor' where a through crack was confirmed. As a result, strain values greater than the analysis value of 204.2 $\mu$  were measured at the S-4 sensor, the location of the through crack. However, a convergence trend was observed over time, enabling the planned management of the high-flowability concrete placement without issue.
