Impact Assessment of Damage Caused by Accidents (Part 2)

Heavy machinery crashes into snow shelter! ——Efforts for early restoration——

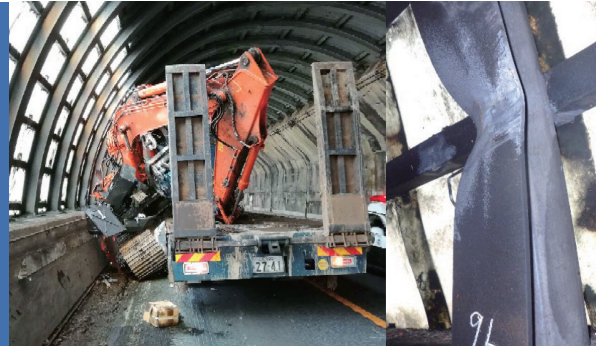
This case study details the impact assessment and emergency restoration response for an incident where a vehicle transporting large heavy machinery lost balance, causing the machinery to collapse from the cargo bed and collide with a snow shelter!! The accident resulted in plastic deformation to numerous support pillars.

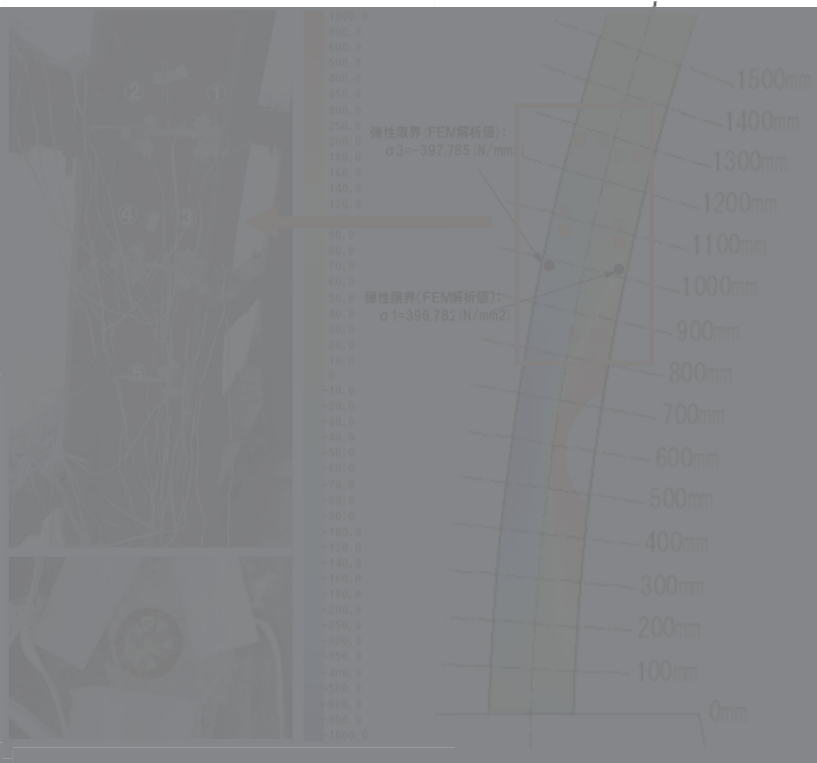
Accident Impact Assessment Using FEM Analysis and Validation of Results from Punching Method

These damages were extensive, necessitating urgent measures for the plastically deformed areas. Therefore, we: ① conducted on-site damage shape verification (dimensional survey), ② identified the plastic regions via FEM analysis based on the damage shapes, and finally ③ performed stress relief measurements using the perforation method to validate the FEM analysis. The right figure shows the FEM analysis results, zoomed in on the web surface. It can be determined that plastic deformation has already occurred from the column base up to approximately 1000mm, exceeding the material's yield strength $\sigma_y = 400 \text{ (N/mm}^2\text{)}$ (material SM400). We investigated the actual stress levels using the perforation method for sections ① to ⑤, indicated by the enclosed areas. The table at the bottom right shows the FEM analysis results and the stress measurement results obtained by the perforation method. While section ⑤ was already plastically deformed, making it impossible to achieve consistency between the two methods, for the remaining elastically deformed sections ① to ④, a very high degree of consistency between the analyzed values and the measured values was confirmed.

【Arrangement of drilling test results and FEM analysis results Unit: N/mm²】

Verification point	Analysis result: α	Drilling test results: β	Ratio: β / α	Plasticity Judgment
Web	1 59,657	60.0	1.006	Elastic range
	2 53,791	47.7	0.887	Elastic range
	3 333,424	337.8	1.013	Elastic range
	4 -357,490	-368.2	1.030	Elastic range
	5 1008,551	425.1	0.421	Plasticization
