# Verification of the Feasibility of Restoration Work for a Truss Bridge with Broken Diagonal Members (Evaluation of Tension Members)

## Truss bridge diagonal members failed!! Secondary stress evaluation of axial force members after reinforcement

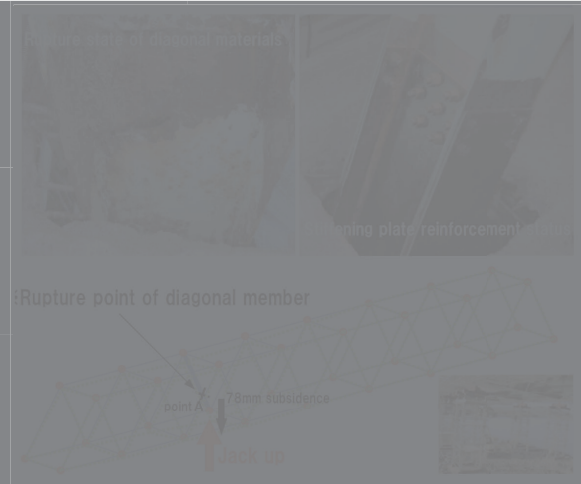
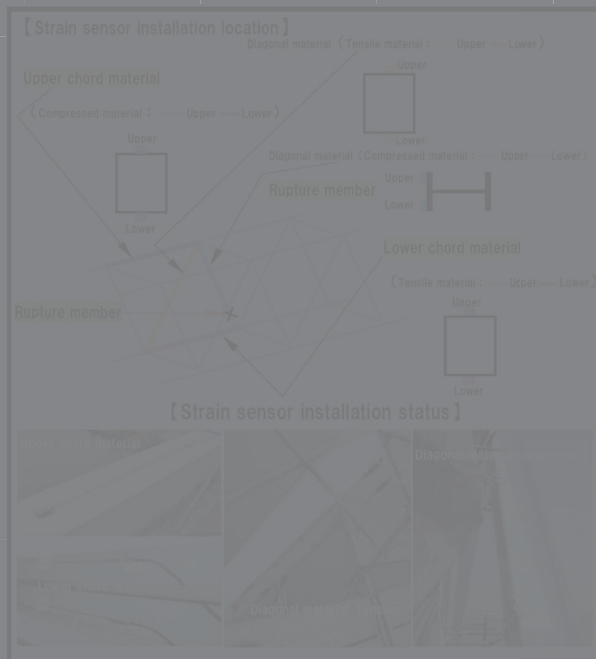
The fractured truss bridge diagonal members were covered by concrete deck slabs for the sidewalk. Their coastal location contributed to the corrosion and subsequent fracture of the truss diagonals. Due to the fracture impact, a maximum downward deformation of 78mm was confirmed at grid point A. Full traffic restrictions were implemented. A SBP barge was floated in the river beneath the girders, and shoring was installed to perform jacking. The reinforcement with backing plates shown in the right photo was implemented under these jacking conditions. The key point of the reinforcement work was the stable fixation of the barge. If the situation had been unstable, it might have been difficult to achieve the required jacking amount. This bridge is a pin truss, and the diagonal members are axial force members. If the required jacking amount was not achieved, secondary stresses due to overall deformation effects could potentially be introduced into the axial force members. Therefore, after completing the reinforcement work, Ueharu conducted a load test to measure and verify whether secondary stresses had developed in the diagonal members, which are axial force members.

This time, measurement sensors (using optical fiber sensors) were installed on both the upper and lower sides of each axial force member (chord members, diagonal members, and lower chord members). It was expected that if the planned jacking-up was performed as scheduled, the stress levels obtained on the upper and lower sides would be nearly identical (with no difference). However, stress differences were confirmed in all measured axial force members (see upper right diagram). In response to this result, the reinforcement plate area on the web section of the diagonal members was extended (see right photo) to create a structure capable of accommodating the difference in stress levels.
