Measurement Technology Using Elastic Waves

Concrete diagnostic technology incorporating various elastic wave theories

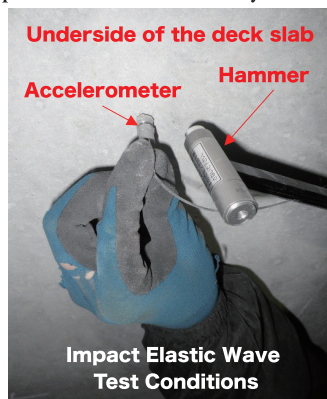
Therefore, by applying the impact elastic wave method to the underside of the slab in a grid pattern, we captured reflected waves from horizontal cracks originating beneath the slab. Through data processing for mapping and visualization, we clearly identified the locations of horizontal cracks within the concrete in a manner easily understandable to anyone.

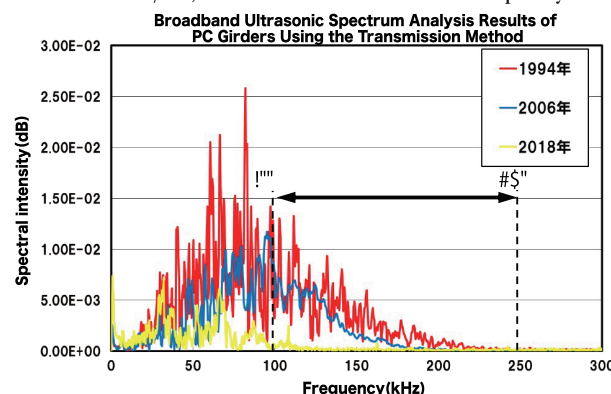
It can be inferred. The left photograph shows the investigation of propagation energy fluctuations by transmitting broadband ultrasonic waves into a PC girder where coarse aggregate expansion was suspected based on ASR analysis. The left diagram shows the results: a significant decrease in propagation energy within the 100–250 kHz frequency band is clearly observed over time from 1994 to 2018.

At Josei, we possess ultrasonic measuring instruments that utilize frequency propagation at 25, 50, and 100 kHz, as well as instruments capable of propagating broadband ultrasonic waves from 0 to 500 kHz simultaneously. Coarse aggregate, a constituent material of concrete, has aggregate diameters of approximately 20 to 50 mm. Generally, the ultrasonic propagation velocity in coarse aggregate is around 5000 m/sec, It can be determined that the frequency range most easily propagated through coarse aggregate is 100 to 250 kHz.
