Repair Measures for Existing Bridges

Restoration of Deteriorated Concrete Gelber Bridge

- Adoption of Chipping Technology Using the WJ Method
- Concept of Cross-Section Repair Work

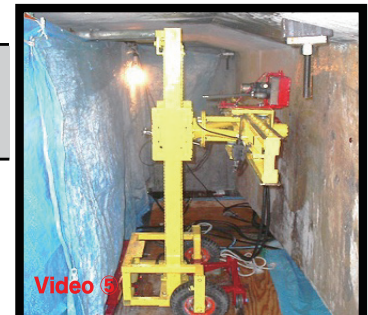
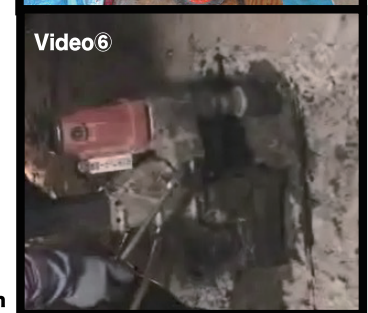
At that time, we also confirmed the specifications of the WJ method suitable for chipping (setting the nozzle spray angle). For five deteriorated concrete girder sides (see above diagram), we performed chipping using the WJ method with four types of nozzles and a breaker (see upper right video). After chipping, cores were sampled and examined using fluorescent penetrant testing to determine the presence and condition of microcracks. (See video and photo on the right) Microcracks were clearly visible in the breaker section core, but none were observed in the WJ method section core. Results of bond strength tests at the new/old concrete interface using the Kenken single-axis hydraulic tensile testing machine (see right diagram) show that the WJ method consistently meets the bond strength standard of 1.5 N/mm² or higher. However, the breaker section exhibits low bond strength, failing to meet even the untreated control value.

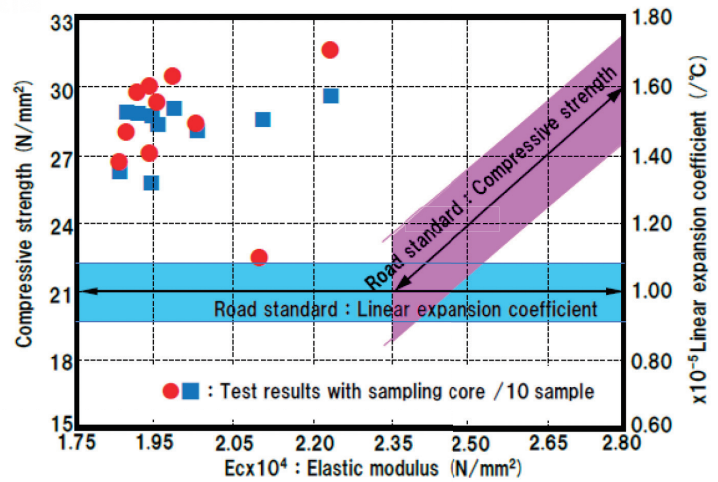
During cross-section repairs, compressive strength tests are conducted as part of the survey of existing concrete structures. Based on these results, it is common practice to estimate the above elastic modulus and select materials accordingly. However, existing concrete structures that have been in service for a long time since completion are subject to deterioration due to natural environmental effects. It is also possible that the distribution of appropriate aggregates, etc., is not stable. The concrete bridge under consideration in this study has been in service for 85 years since completion. The relationship between the compressive strength and the elastic modulus and linear expansion coefficient obtained from cores taken from the main girders is shown in the figure on the right. Compressive strength: σ_{ck} is concentrated between 27 and 30 N/mm², leading to an estimated elastic modulus: E_c of 2.65 to 2.80×10^4 N/mm² (■ range). However, test results showed a significant tendency for values to fall substantially lower, between 1.85 and 2.05×10^4 N/mm². Furthermore, while the linear expansion coefficient is specified in the road standards as approximately $\alpha = 1.00 \times 10^{-5} / ^\circ\text{C}$ (■ range), the actual values were significantly higher at 1.40 to $1.60 / ^\circ\text{C}$.

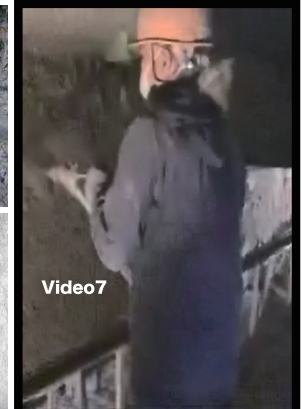
Currently, a monitoring system is being implemented for concrete bridges that have undergone cross-section repair measures to track the future progression of deterioration over time (see left video). This system focuses on the principle of current changes associated with steel corrosion and plays a role in verifying the effectiveness of repairs.
