## Repair Measures for Existing Bridges

### Overseas Project / Cambodia in JICA Chroy Changwar Bridge Steel Deck Fatigue Crack Countermeasures

## Study on Countermeasures for Fatigue Cracks in Steel Deck Plates

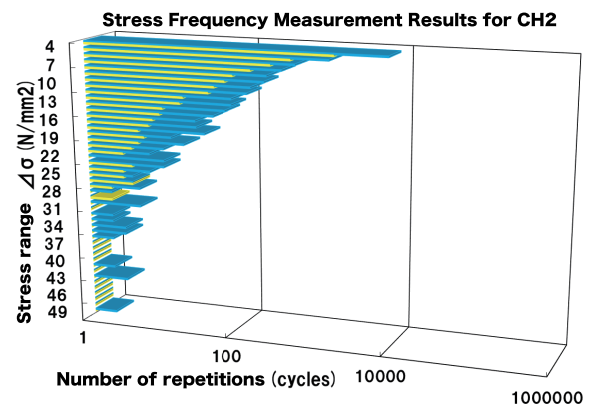
[Verification of Reinforcement Effectiveness Using Stress Frequency Rules; CH1 and CH2]

The photo on the right shows the installation overview and condition of strain gauges on the sound section where no beat progression cracks have occurred. The strain gauges are bonded to the deck plate and U-ribs at a position 5mm from the weld. Traffic volume on the Chroy Changwar Bridge currently exceeds 45,000 vehicles per day. Stress frequency measurements were conducted for the 12-hour traffic period from 7:00 to 19:00 on weekdays.

The ■ in the lower graph represents the stress frequency results before countermeasures, while ■ represents the results after countermeasures. A significant reduction in count numbers can be confirmed for both CH1 and CH2. Furthermore, stress levels above 30 N/mm<sup>2</sup> have been reduced to zero, indicating that the countermeasures have sufficiently extended the fatigue life.

As shown in the photo below, construction began in January 2017 and was completed in June 2019. At Josei, stress frequency measurements were conducted before and after the countermeasures to verify the effectiveness of the reinforcement measures.
