Repair Measures for Existing Bridges

Investigation of Causes and Countermeasure Design for Fatigue Cracks in Steel Bridges and Post-Countermeasure Effect Verification (Part 2)

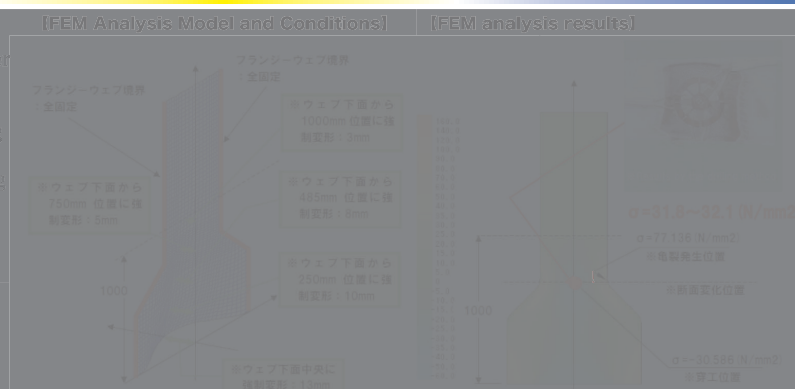
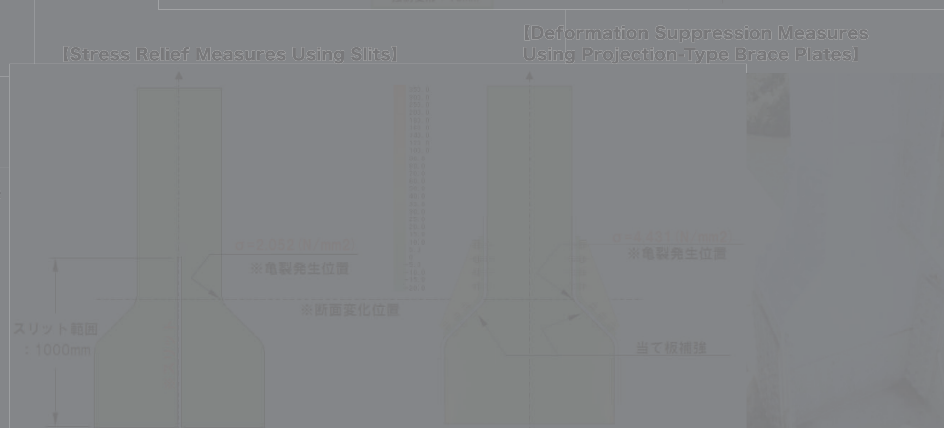
As shown in the right figure, we applied a forced displacement measured on the vertical web member to evaluate the local stress level at the crack initiation point. Additionally, we measured the residual stress level at the ●-marked location using the drilling method to verify the validity of the analysis model. The agreement between the drilling method results ($\sigma=31.8\sim32.1\text{ N/mm}^2$) and the FEM analysis results ($\sigma=30.6\text{ N/mm}^2$) confirmed the validity of the analysis model. Consequently, it was determined that an extremely high local stress of $\sigma=77.1\text{ N/mm}^2$ had already developed at the crack initiation point. We concluded that the stress from repeated loading accumulated at this point, leading to the formation of a fatigue crack.

The key consideration in countermeasures is how to eliminate the stresses generated by this forced bending deformation. Two countermeasure proposals were evaluated: ① Stress relief through slits and ② Deformation suppression using protruding backing plate reinforcement. Option ② was adopted, prioritizing a reliable stress reduction strategy.
