## Temperature Stress Management During Concrete Placement

# Construction Management for Seismic Reinforcement Work on Concrete Bridge Piers Damaged by the Kumamoto Earthquake

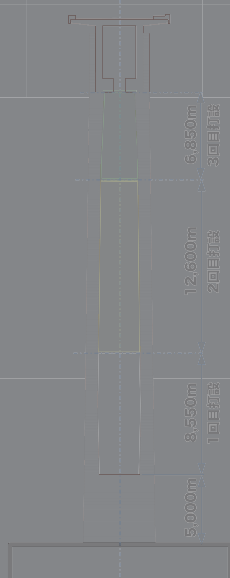
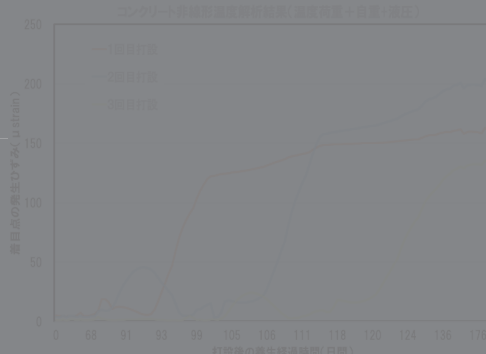
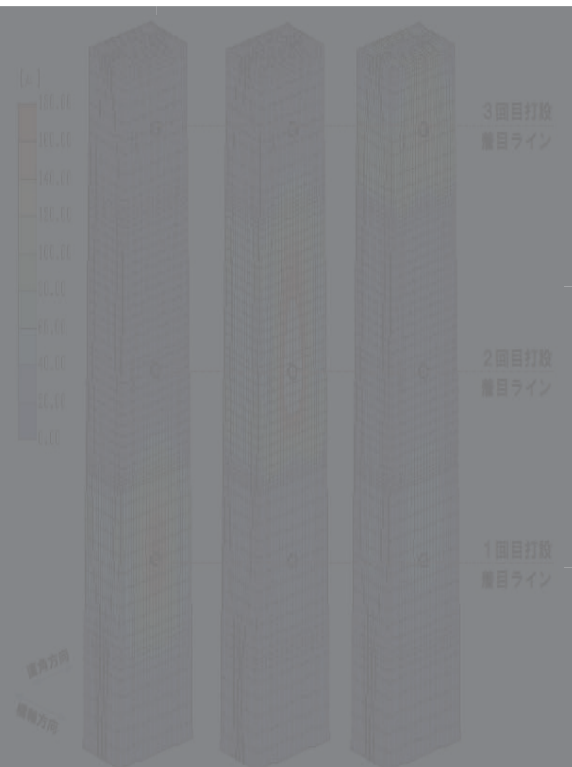
Concerns regarding concrete placement included: 1. bulging due to the concrete's own weight and liquid pressure, and 2. expansion of the pier structure caused by hydration heat reactions during placement and curing. Therefore, to establish judgment (control) criteria during construction, nonlinear temperature analysis of the concrete (hydration heat model: JCI2008) was performed using FEM analysis.

The analysis conditions were set as follows: three pours of high-flow concrete with a compressive strength of  $\sigma_{ck}=24 \text{ N/mm}^2$ , a pour interval of two weeks, and an initial pour temperature of approximately 16 °C, assuming April conditions for the region. As a result, the maximum strain developed was  $\epsilon=135.6$  to  $204.2 \text{ } \mu\text{strain}$ , which was suppressed to below 25% of the allowable value.

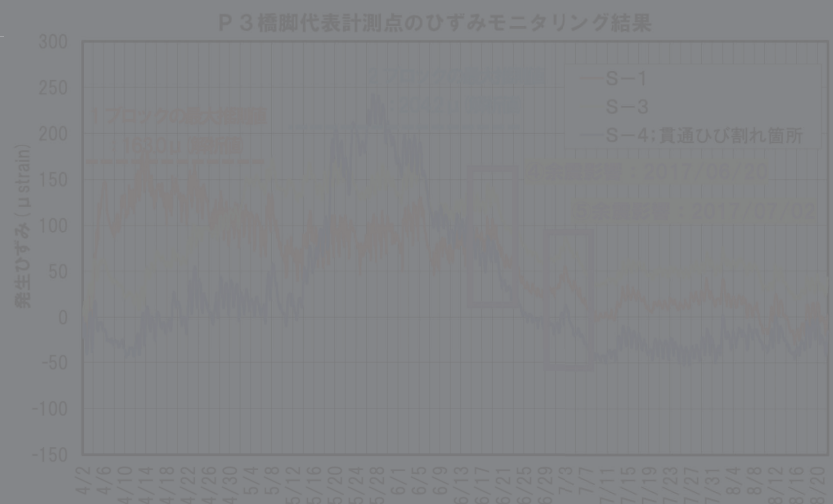
The selected measurement locations are the 'S-1 Sensor' with a high per-pour volume, the 'S-3 Sensor' located at the center of the pier, and the 'S-4 Sensor' where a through crack was confirmed. As a result, strain values greater than the analysis value of 204.2 $\mu$  were measured at the S-4 sensor, the location of the through crack. However, a convergence trend was observed over time, enabling the planned management of the high-flowability concrete placement without issue.
